Photographic Log for Memphis Regional Intermodal Facility

Operator:		Site Location:	Tracking No.:
Norfolk Southern Railway Company		Rossville, Fayette County	TN0081108
Photo No.	Date		
1	8-30-12		
Description <ul style="list-style-type: none"> • Phase 1A EC-11 • The swale located south of the eastern wye track and main line track up-gradient from SW23 is shown in this photo. • The bottom of the swale appeared to be sufficiently stabilized/vegetated. However, the slopes of the berm were not - see photo 2 for close-up of berm. • Although the berm appears to have more established vegetation than during the March 12, 2012, inspection, the berm remains insufficiently stabilized/vegetated.

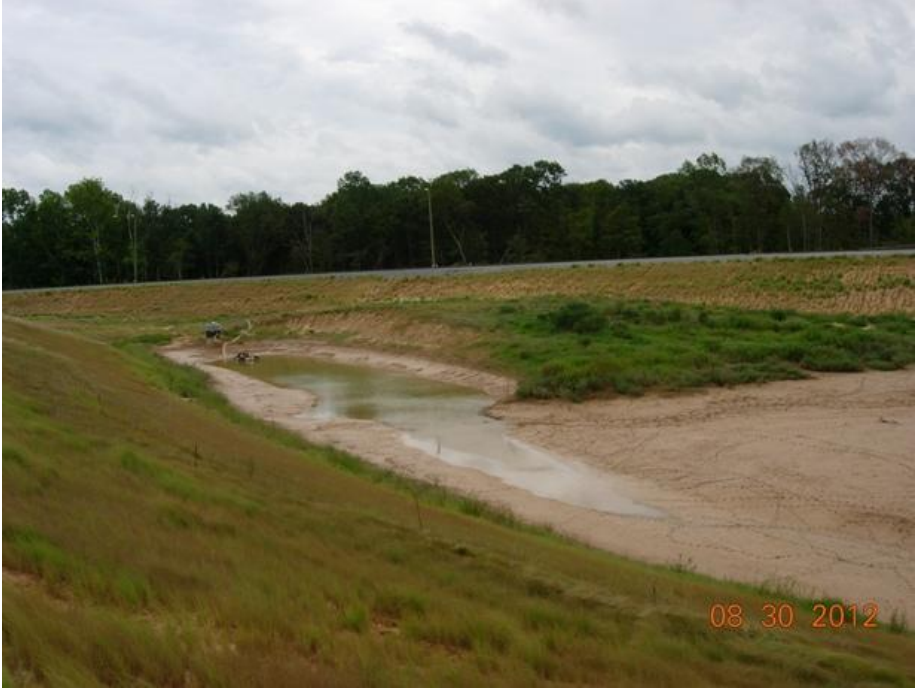
Operator:		Site Location:	Tracking No.:
Norfolk Southern Railway Company		Rossville, Fayette County	TN0081108
Photo No.	Date		
49	8-30-12		
Description <ul style="list-style-type: none"> Phase 1A EC-14 and 2 EC-24 Looking northeast at the northern end of Sediment Basin 1. The banks of the basin were not sufficiently vegetated. Rills and gullies were observed. Although the banks appeared to have more established vegetation than during the August 23, 2011, November 22, 2011, and March 12, 2012, inspections, the banks remain insufficiently stabilized/vegetated. A close-up view of the unstable eastern bank of the basin is shown in photo 50. The basin was not discharging at the time of the inspection.

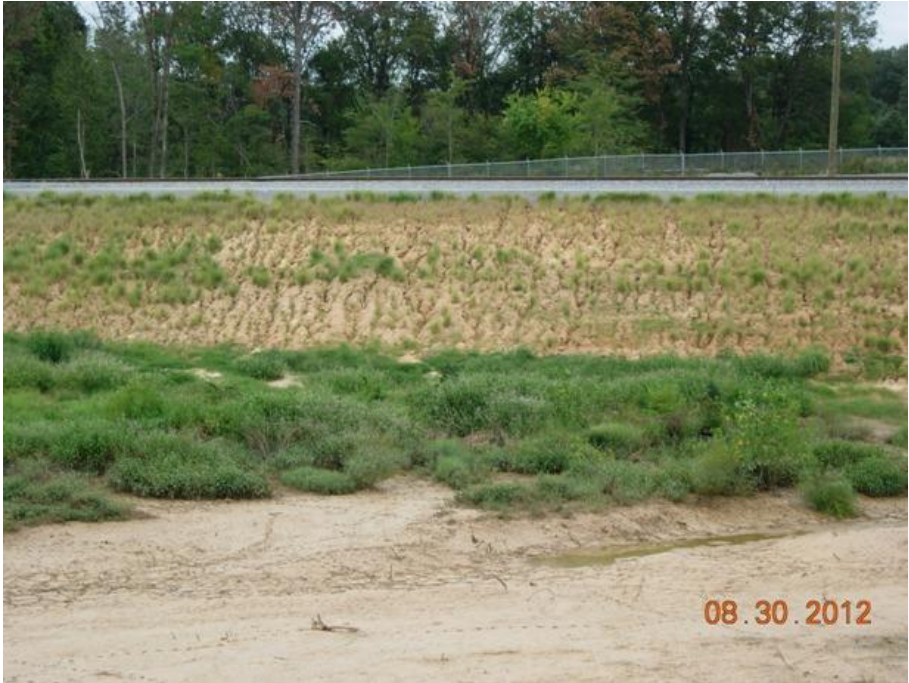
50	8-30-12		
Description <ul style="list-style-type: none"> Phase 1A EC-14 and 2 EC-24 The eastern bank of Sediment Basin 1 is shown in this photo. The bank is not sufficiently stabilized/vegetated. Although the banks appeared to have more established vegetation than during the August 23, 2011, November 22, 2011, and March 12, 2012, inspections, the banks remain insufficiently stabilized/vegetated. Rills and gullies were observed.

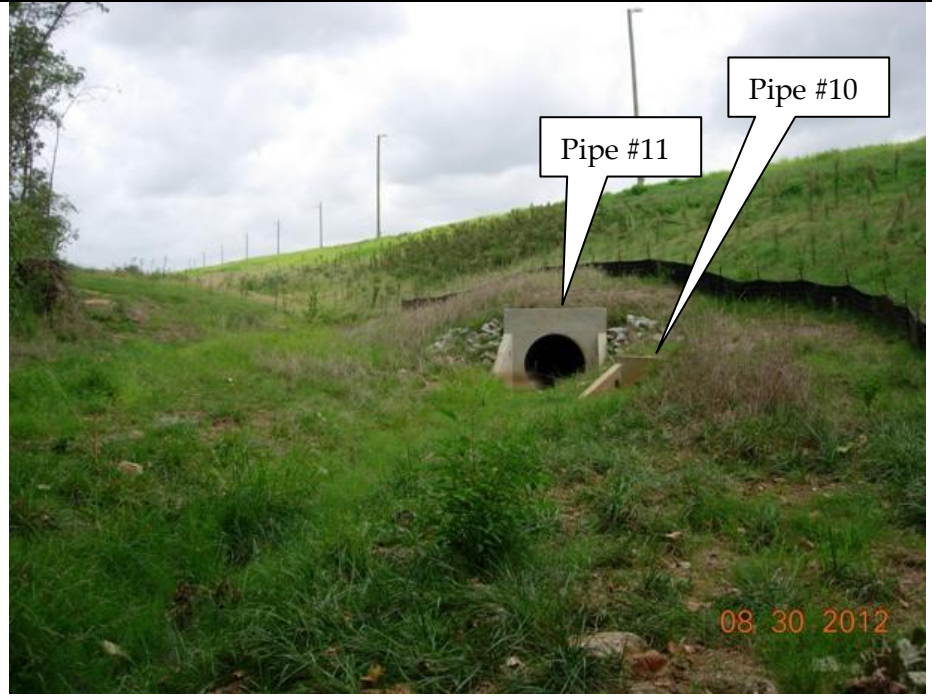
52	8-30-12		
Description <ul style="list-style-type: none"> • Phase 2 EC-24 • The outlet ends of Pipe #11 and Pipe #10 are shown in this photo. • Pipe #11 receives drainage from Sediment Basin 1, which was not discharging at the time of the inspection. • No discharge was occurring from Pipe #10. • Discharge flowing to SW9 from the northern draining eastern drainage ditch/Sediment Basin 8 was observed. The discharge water appeared clear.

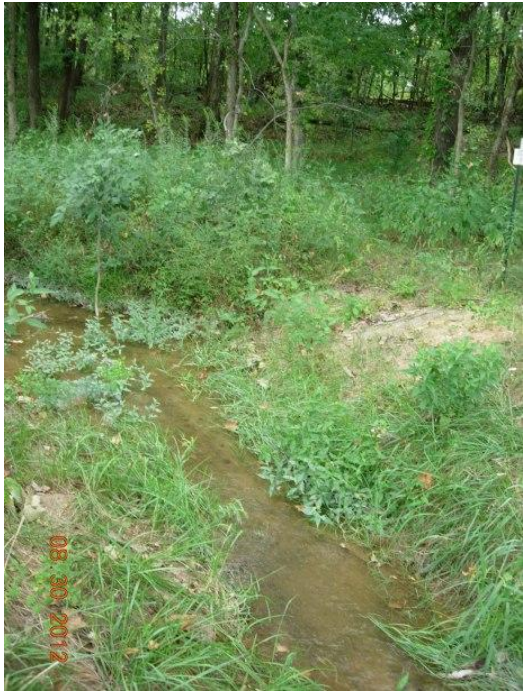
Operator:		Site Location:	Tracking No.:
Norfolk Southern Railway Company		Rossville, Fayette County	TN0081108
Photo No.	Date		
53	8-30-12		
Description <ul style="list-style-type: none"> • Phase 2 EC-24 • SW9 • Discharge from the northern draining eastern drainage ditch/Sediment Basin 8 was observed flowing to SW9 and into Stream 5. The discharge water appeared clear. • The row of enhanced silt fence observed during previous inspections had been removed. • The area immediately surrounding SW9 appeared to be sufficiently stabilized/vegetated.

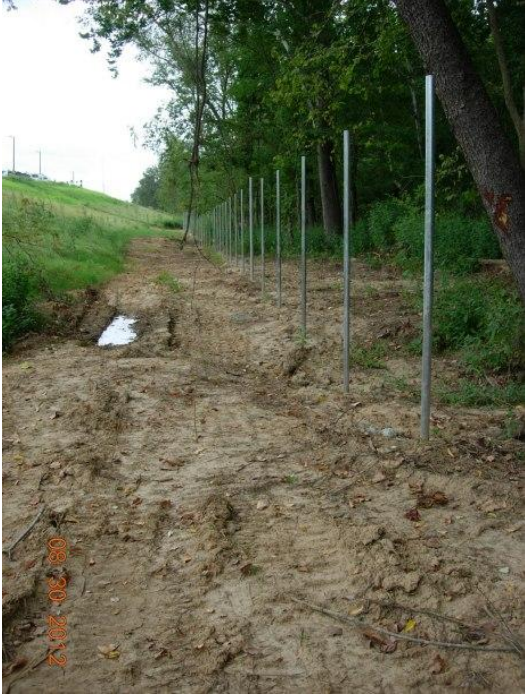
55	8-30-12		
Description <ul style="list-style-type: none"> • Phase 2 EC-24 • The fence installation along the limits of clearing, west of Stream 5, has caused disturbance. • No erosion prevention or sediment controls were observed.

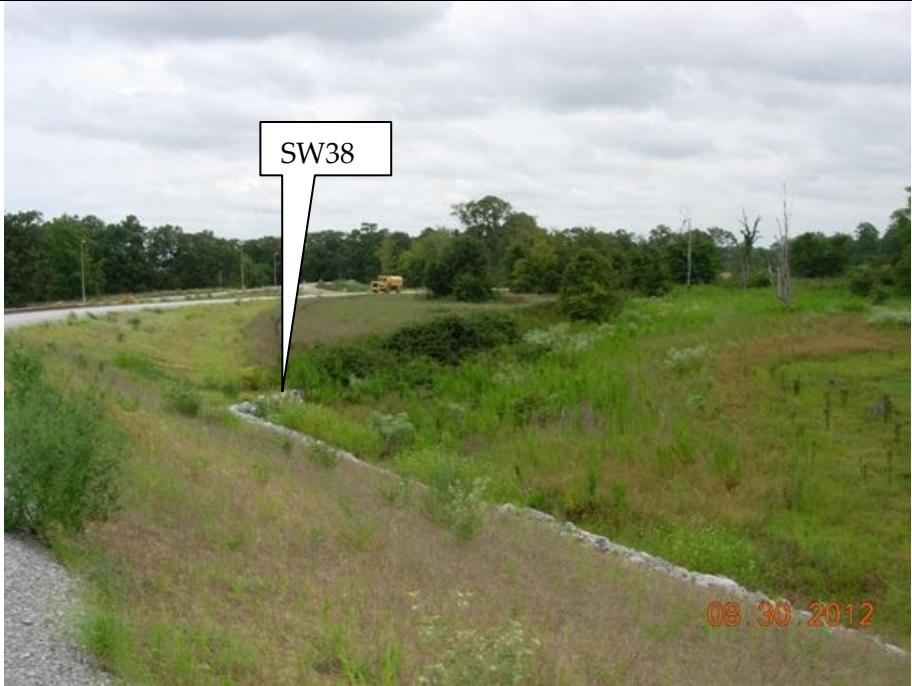
60	8-30-12		
Description <ul style="list-style-type: none"> • Phase 2 EC-30 • SW38 • SW38 discharges to Pond 4. • The slope and swale associated with SW38 appeared to be sufficiently stabilized/vegetated; however, sparse coverage was observed on the slope between SW38 and Pipe #31- see photos 61 and 62.

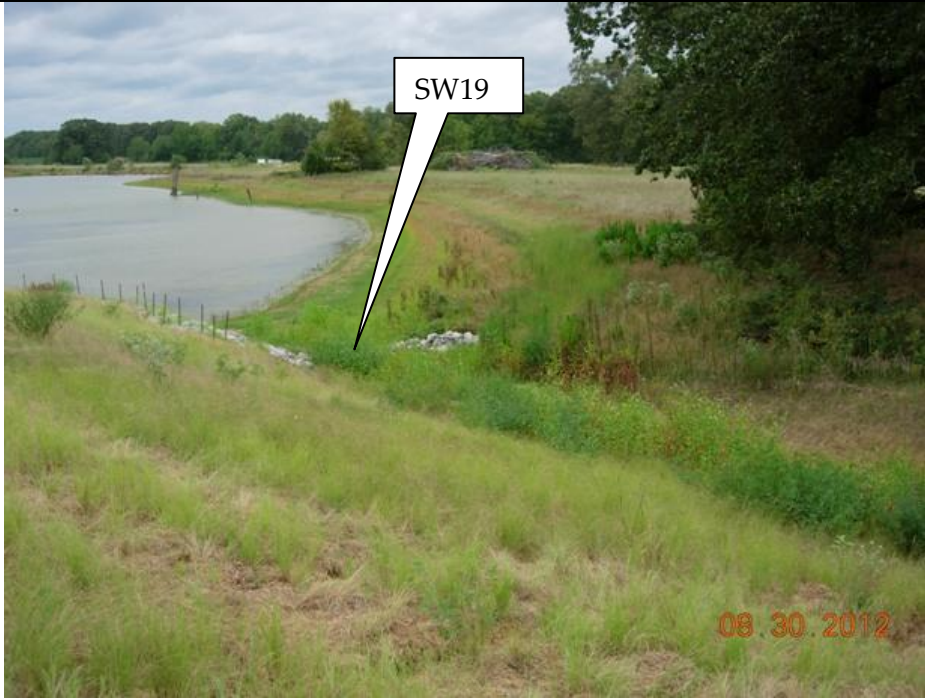
63	8-30-12		
Description <ul style="list-style-type: none"> Phase 2 EC-30 SW19 SW19 discharges into Pond 4. Portions of the slope and swale associated with SW19 appeared to have sufficient vegetation. However, some areas were sparsely vegetated. Rills and gullies were observed.

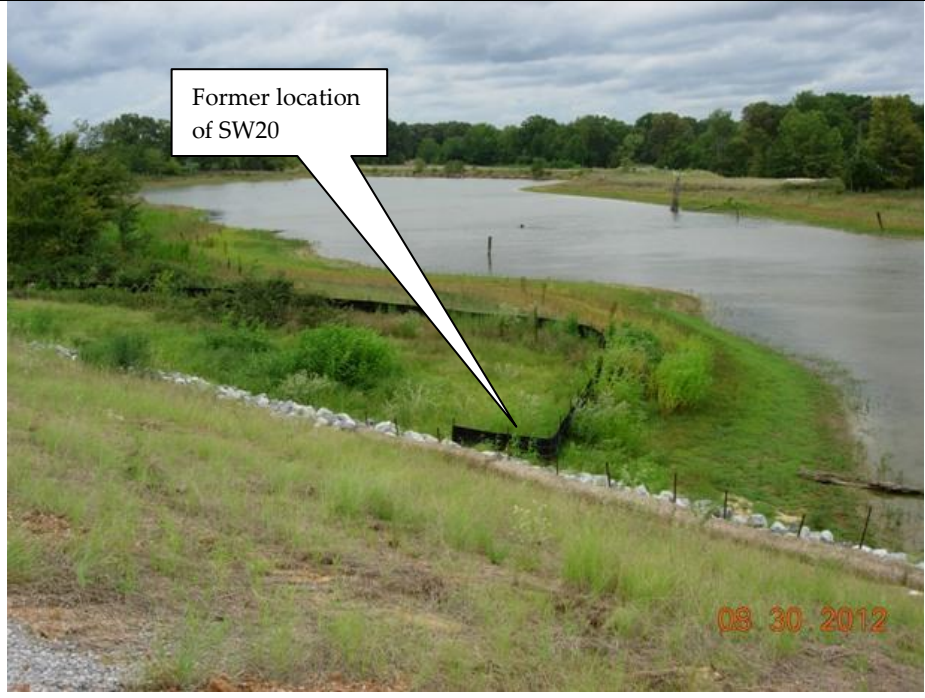
64	8-30-12	
Description <ul style="list-style-type: none"> Phase 2 EC-30 Former location of SW20 The area surrounding SW20 appeared mostly sufficiently stabilized. However, sparse vegetation on the slope up-gradient of the outfall and Pond 4 was observed.

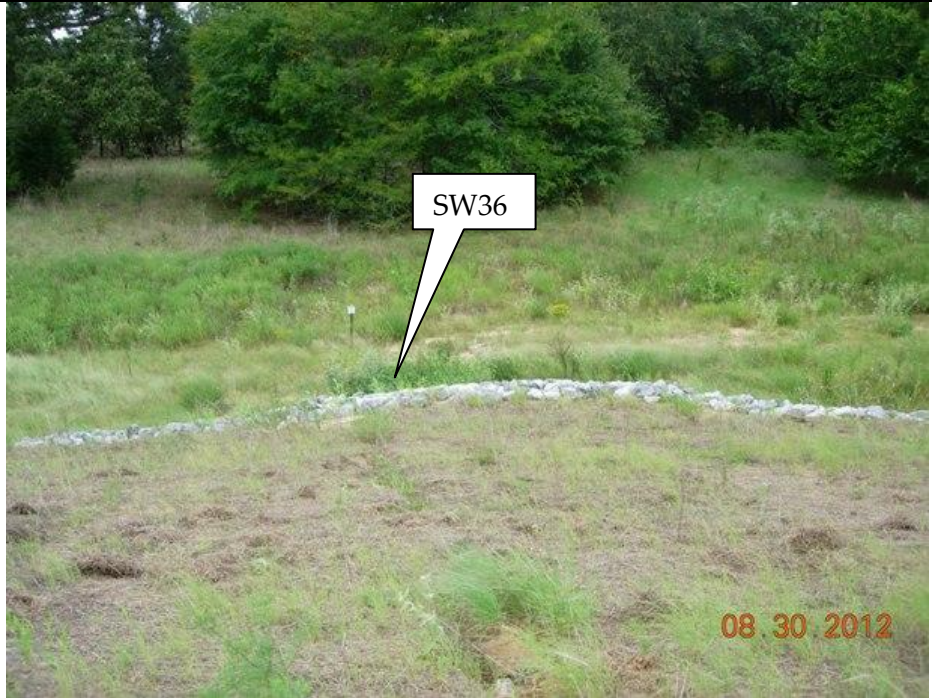
65	8-30-12		
Description <ul style="list-style-type: none"> • Phase 2 EC-27 • SW36 and the location of the inlet end of Pipe #32 are shown in this photo. • Pipe #32 discharges into Pond 4. • The swales leading to SW36 appeared to be mostly sufficiently vegetated, but sparse areas were observed. 			
Photo No.	Date

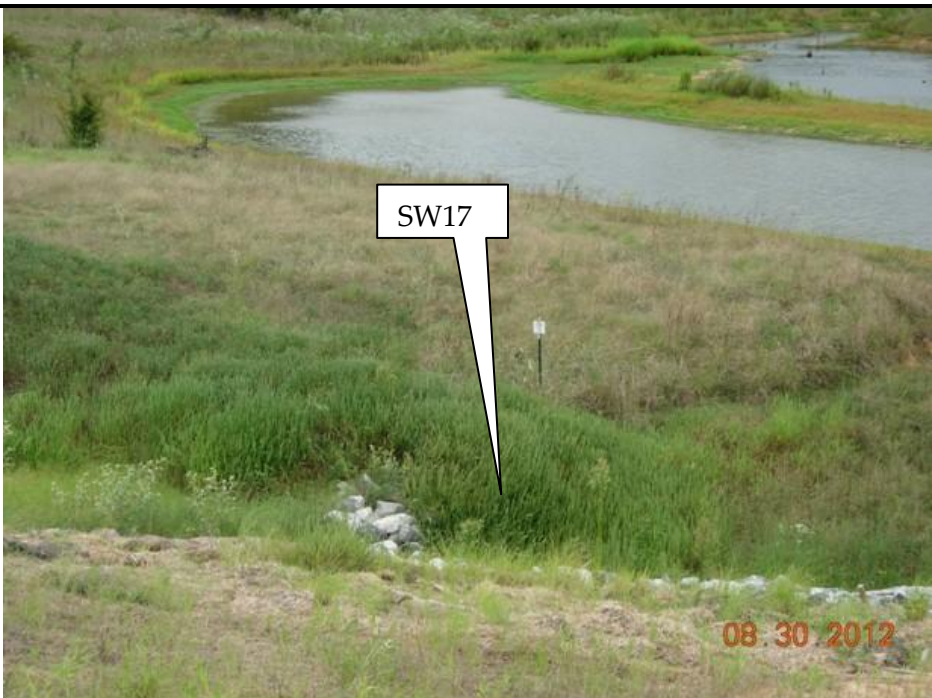
66	8-30-12		
Description <ul style="list-style-type: none"> • Phase 2 EC-27 • SW17 • The area surrounding SW17 appeared sufficiently vegetated. However, the swale/slope which conveys drainage to SW17 was not sufficiently stabilized/vegetated in some areas (see photos 67-68).

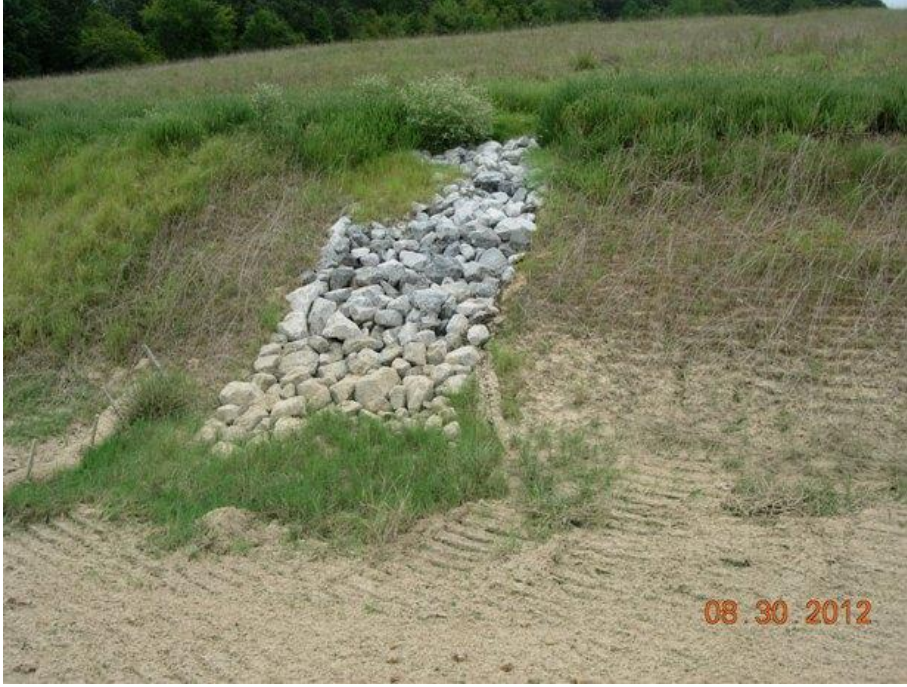
Photo No.	Date		
68	8-30-12		
Description <ul style="list-style-type: none"> • Phase 2 EC-27 • This photo was taken near Station 180+00 on the Loop Track. This area discharges to SW17. • Ms. Hagerty explained that this area was re-graded and covered with Flexterra approximately one month prior to this inspection. • No vegetative growth was observed yet.

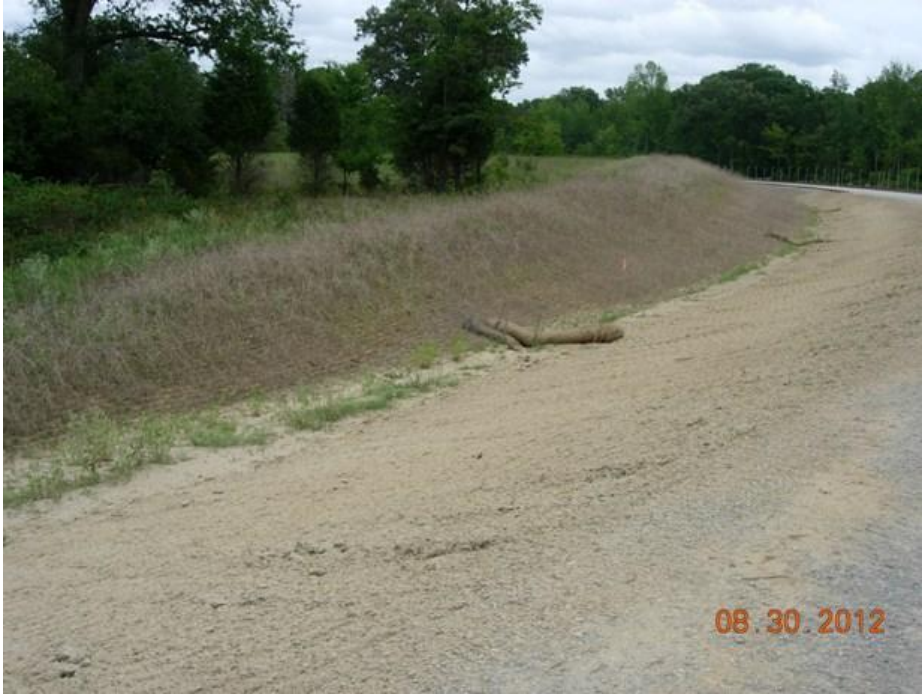
69	8-30-12		
Description <ul style="list-style-type: none"> • Phase 2 EC-27 • This photo was taken near Station 180+00 on the Loop Track. This area discharges to SW36. • Ms. Hagerty explained that the area was re-graded and covered with ProMatrix. • No vegetative growth was observed yet.

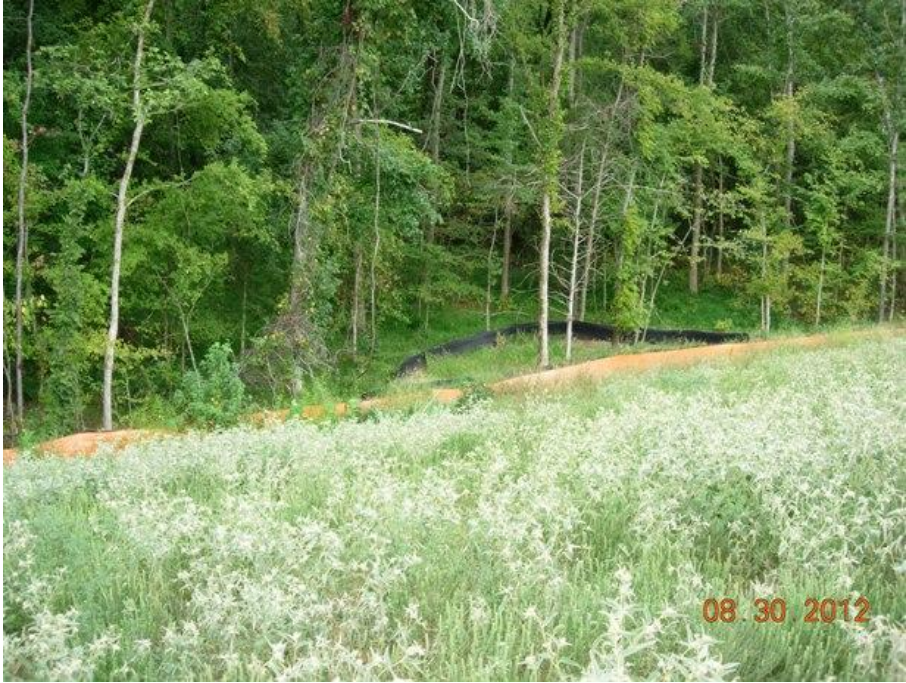
70	8-30-12		
Description <ul style="list-style-type: none"> • Phase 2 EC-27 • Former location of SW39 • The slope up-gradient from the former location of SW39 appeared to be sufficiently vegetated; however, coverage was sparse and insufficient in some areas.

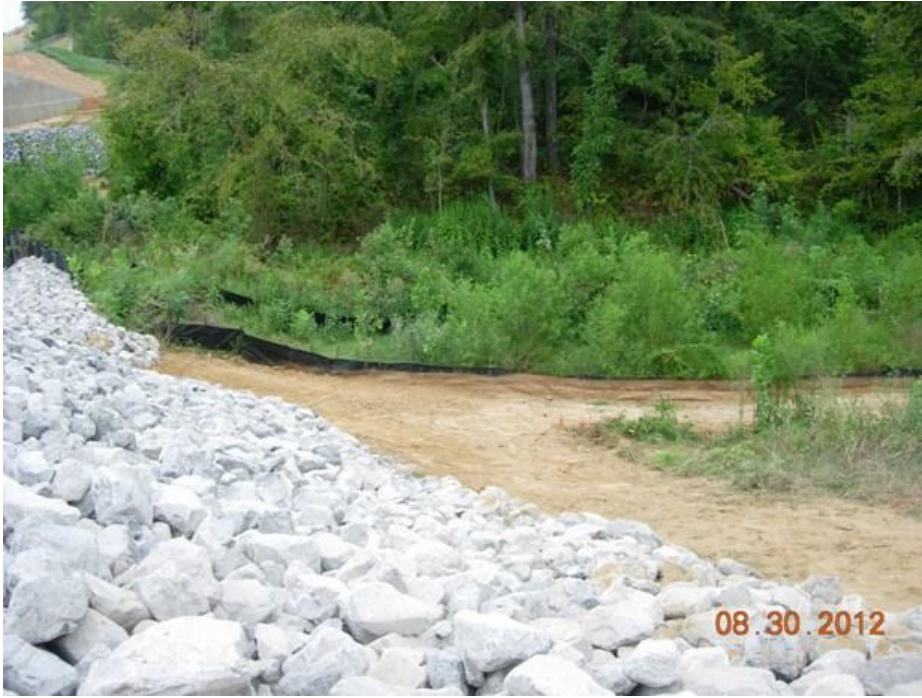
Operator:		Site Location:	Tracking No.:
Norfolk Southern Railway Company		Rossville, Fayette County	TN0081108
Photo No.	Date		
71	8-30-12		
Description <ul style="list-style-type: none"> • Phase 1A EC-17 • SW14 • SW14 discharges into Stream 6; however, no discharge was occurring at the time of the inspection. • Sediment accumulation appeared to have been recently removed from the silt fence. • Based on the sediment staining on the silt fence, sediment accumulation had reached the top of the fencing. • Areas adjacent to SW14 were not sufficiently vegetated.

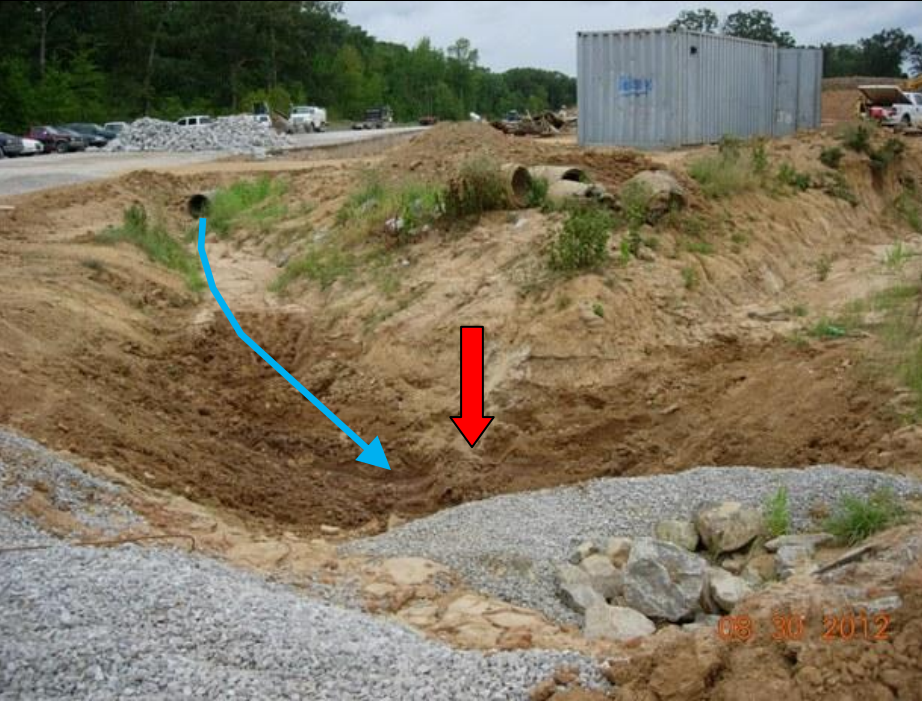
Photo No.	Date		
72	8-30-12		
Description <ul style="list-style-type: none"> • Phase 1A EC-17 • The area shown in this photo is the area between Stations 160+00 and 215+00 on Loop Track LP-1. • Discharge from the western side of the eastern portion of the Loop Track-169+00-161+00 (blue arrow) flows through this area toward SW 13. • Ms. Hagerty stated that a sump (red arrow) was created up-gradient of the inlet end of the pipe.

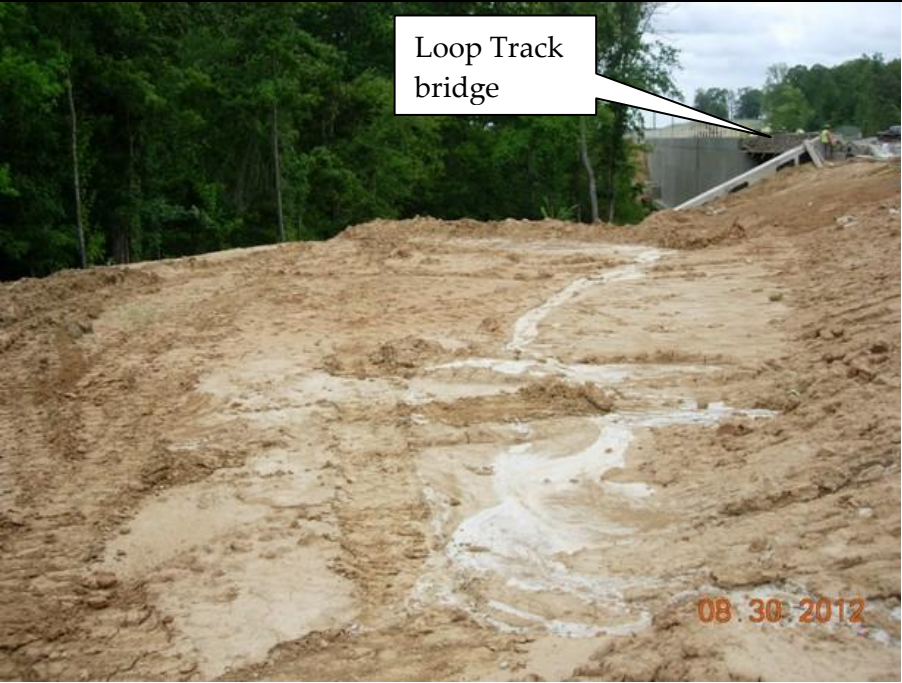
73	8-30-12		
Description <ul style="list-style-type: none"> • Phase 1A EC-17 • Looking north at an area of disturbance on the southwestern corner of the Loop Track bridge. • No erosion prevention or sediment control measures were observed in this area. • This area drains to the north toward Stream 6.

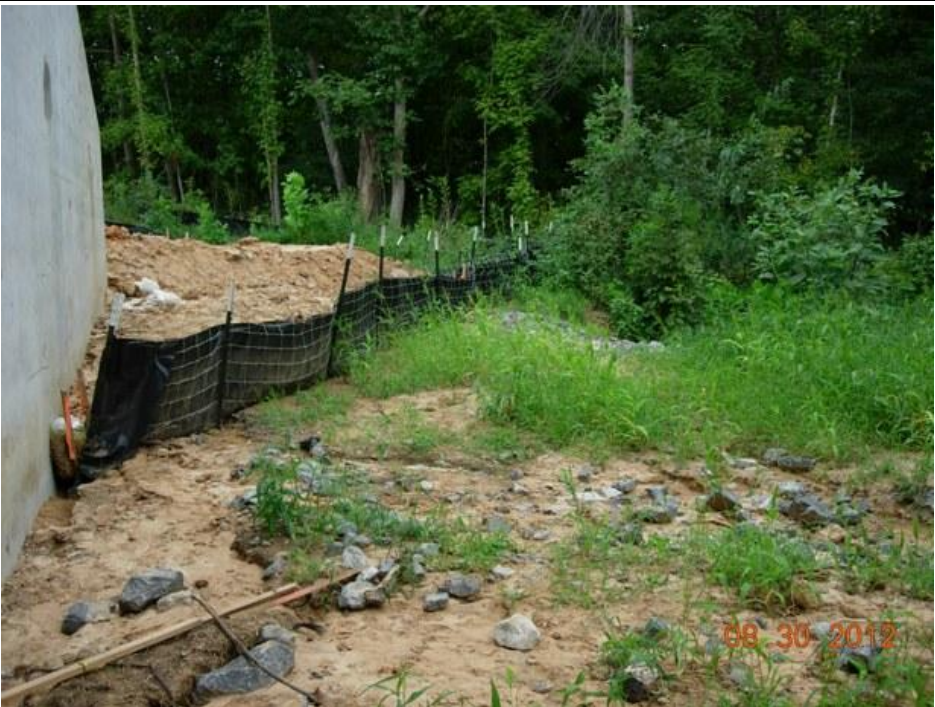
74	8-30-12	
Description <ul style="list-style-type: none"> • Phase 1A EC-17 • The southwestern corner of the Loop Track bridge adjacent to Stream 6 is shown in this photo. • Sediment accumulation was observed covering the top of the stream bank down-gradient from the silt fence evidencing that sediment has escaped the silt fence and is not sufficient.

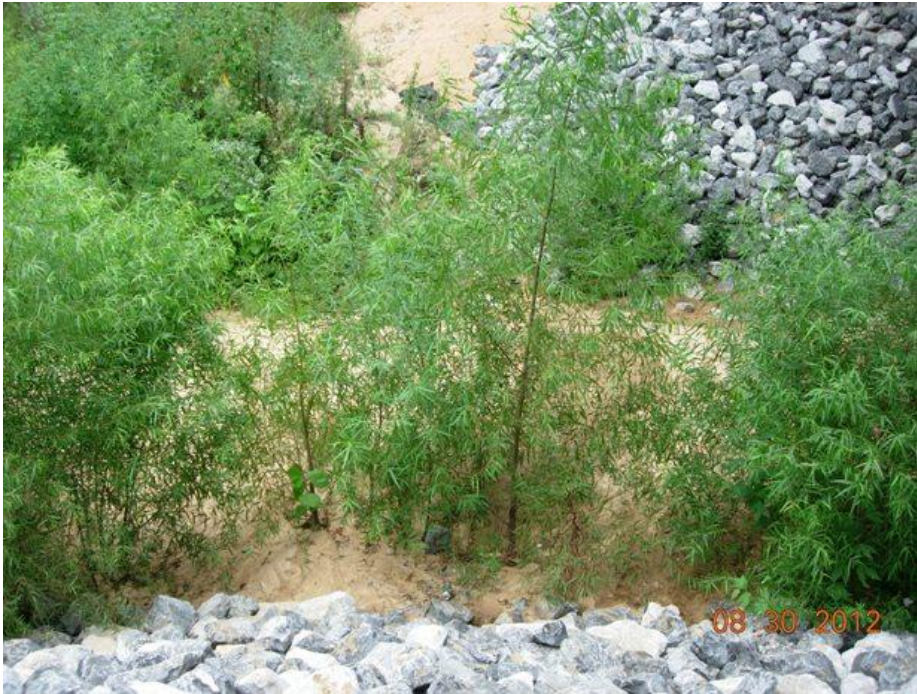
Photo No.	Date		
76	8-30-12		
Description <ul style="list-style-type: none"> • Stream 6 at the confluence of the northwest and southwest corners of the Loop Track bridge is shown in this photo. • Sediment accumulation appeared to be covering the bed of Stream 6 at the confluence point. • Stream 6 could not be safely accessed due to the steepness of the bank. • No water was observed in Stream 6 at the time of the inspection.

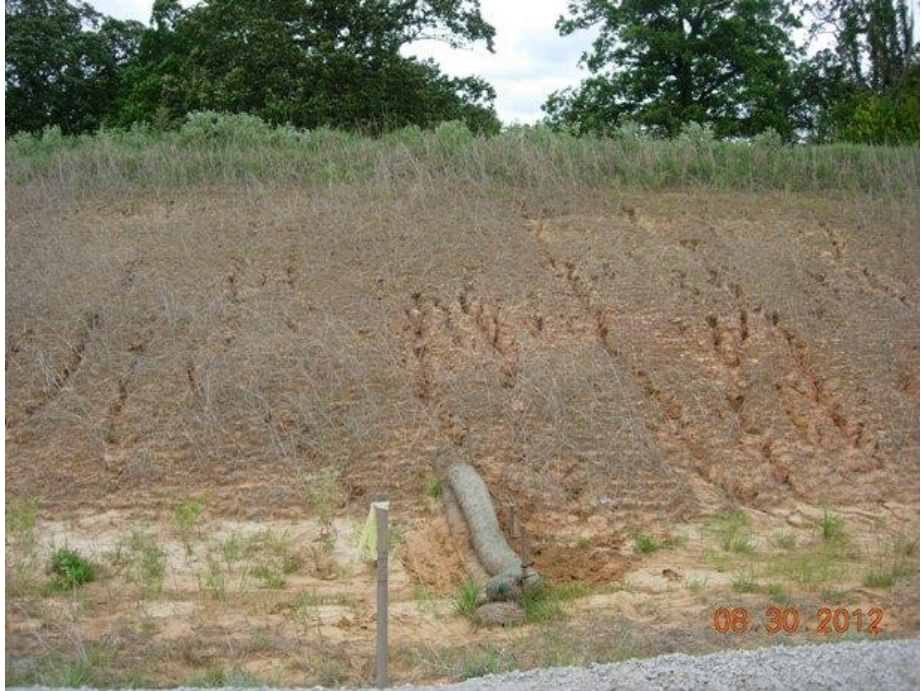
Operator:		Site Location:	Tracking No.:
Norfolk Southern Railway Company		Rossville, Fayette County	TN0081108
Photo No.	Date		
77	8-30-12		
Description <ul style="list-style-type: none"> • Phase 1A EC-17 • This photo is an example of the northern side of the Loop Track. • The photo was taken at approximately Station 210+00. • Rills and gullies were observed. • The vegetation was dead or dormant and did not appear permanent or perennial. • Vegetative cover was not sufficient.

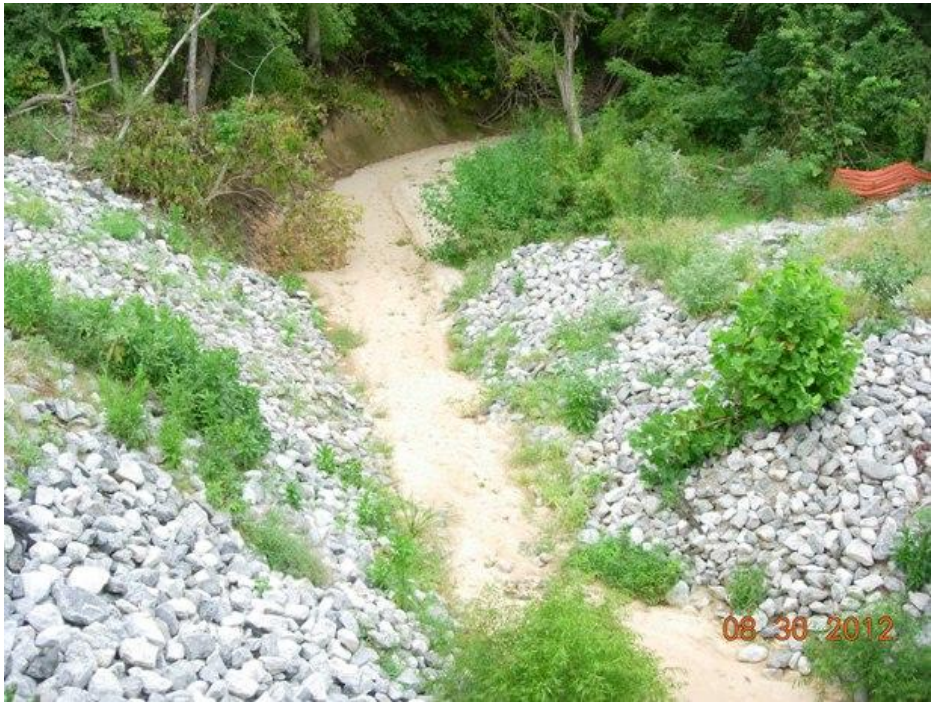
80	8-30-12	
Description <ul style="list-style-type: none"> • Phase 2 EC-27 • Looking downstream at Stream 6 from the permanent road (entrance road) bridge over Stream6. • No flow was observed in Stream 6.

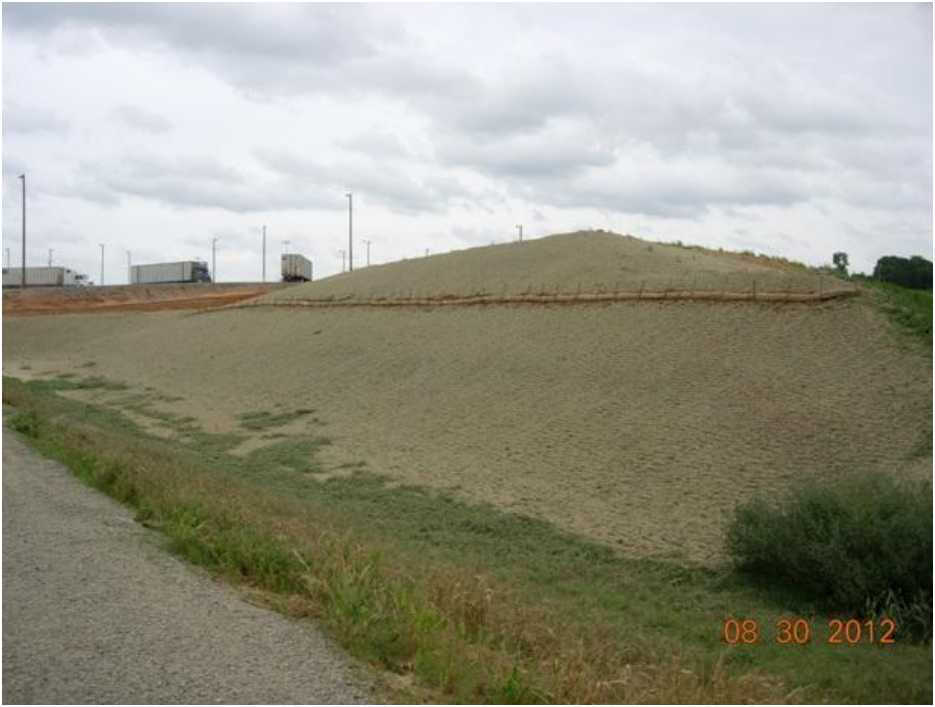
81	8-30-12		
Description <ul style="list-style-type: none"> • Phase 2 EC-26 • The area shown in this photo discharges to the northeast corner of the permanent road (entrance road) bridge over Stream 6 (see photo 83). • Ms. Hagerty stated that the stockpile was covered with Flexterra earlier in the week. • No vegetation was observed in the newly sprayed areas. 			
Photo No.	Date

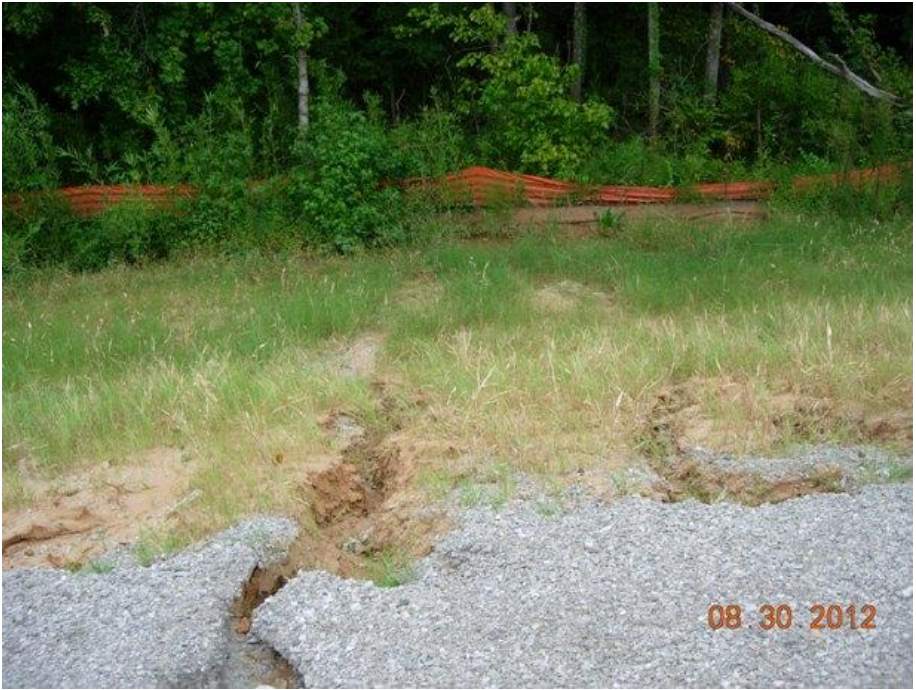
82	8-30-12		
Description <ul style="list-style-type: none"> • Phase 2 EC-27 • The slope/swale up-gradient from the northeast corner of the permanent road (entrance road) bridge over Stream 6 was not sufficiently vegetated as shown in this photo. • Rills and gullies were observed. • Silt fence located at the toe of the slope appeared to be past 50% capacity.

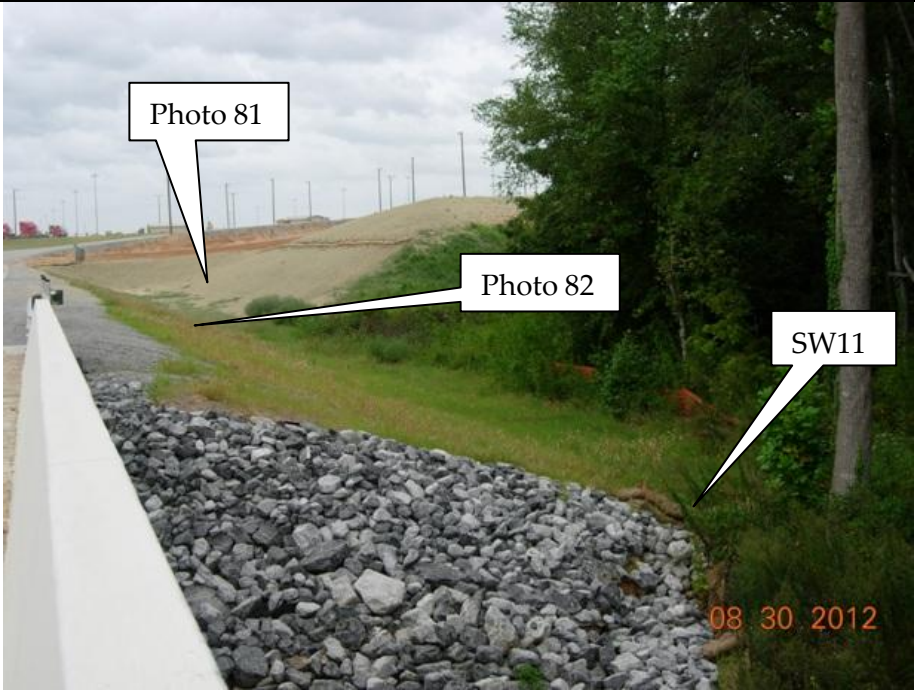
83	8-30-12		
Description <ul style="list-style-type: none"> • Phase 2 EC-27 • Looking north at the northeast corner of the permanent road (entrance road) bridge over Stream 6. • Ms. Hagerty indicated that the location of SW11 has been moved to the swale on the northeast corner of the permanent road bridge over Stream 6. • The locations of photos 81 and 82 are noted. 			
Photo No.	Date

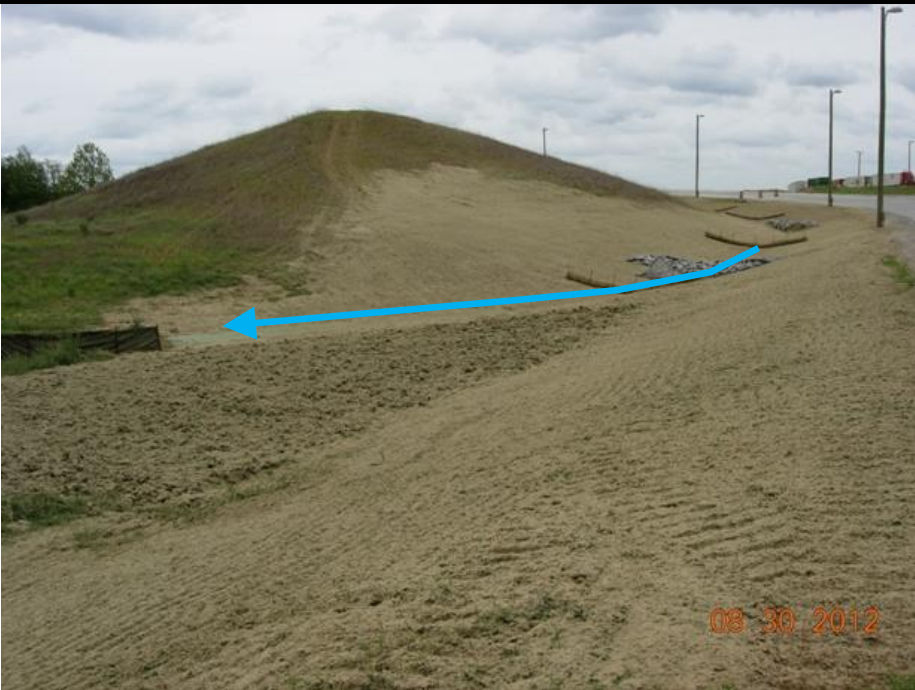
84	8-30-12		
Description <ul style="list-style-type: none"> • Phase 2 EC-26 and EC-27 • The blue arrow indicates the discharges directed towards SW33. • Ms. Hagerty stated that the check dams and straw wattles were installed earlier in the week. She also indicated that the area was sprayed with Flexterra earlier in the week. • No vegetation was observed in the newly sprayed areas.

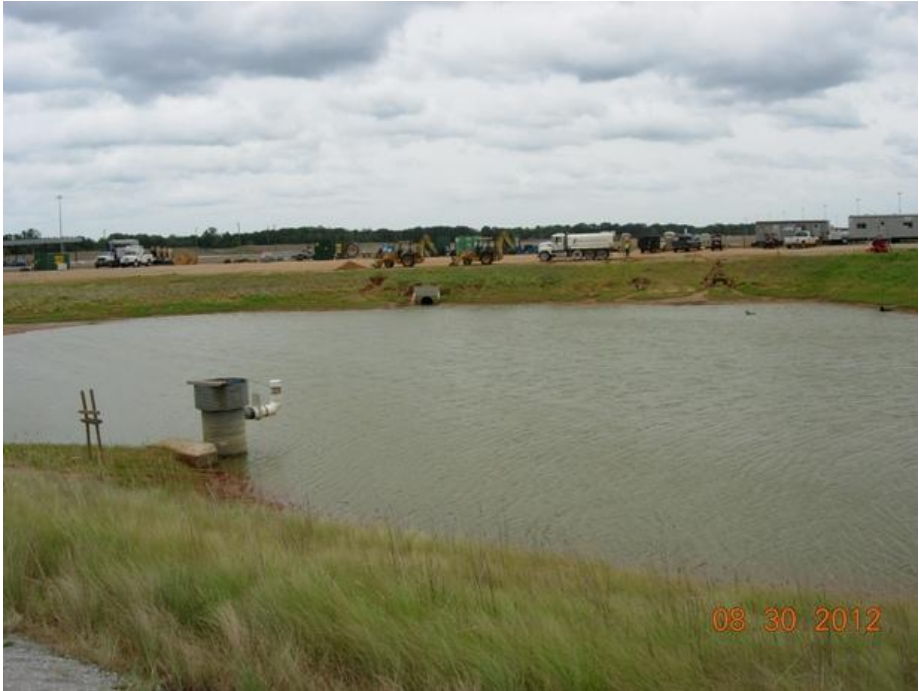
85	8-30-12		
Description <ul style="list-style-type: none"> Phase 1A EC-16 Sediment Basin 4 Weeping Lovegrass was establishing on the banks of the basin; however, sparse vegetative cover was observed in some areas. Rills and gullies were observed on the banks of the basin-see photo 86. The basin was not discharging at the time of the inspection.

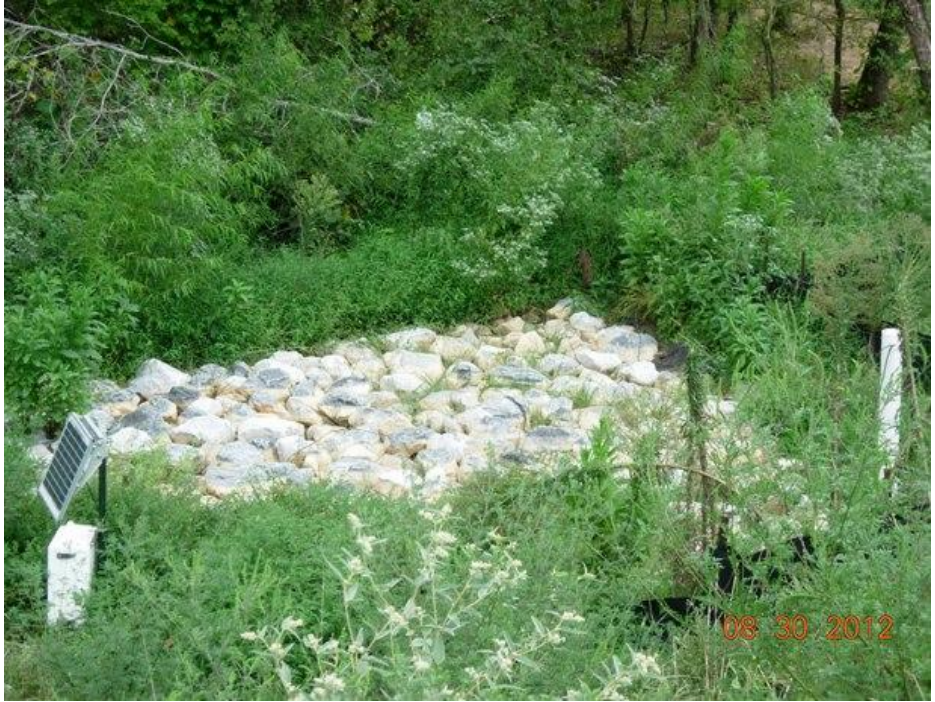
Photo No.	Date	
87	8-30-12	
Description <ul style="list-style-type: none"> • Phase 2 EC-29 • SW37 (outlet end of Pipe #40) • SW37 is the discharge point of Sediment Basin 4 and discharges into Stream 4. • No discharge was occurring at the time of the inspection. • Although the slope adjacent to and up-gradient from SW37 appeared to have more established vegetation than during the March 12, 2012, inspection, the area remains insufficiently vegetated (see photo 88). • Rills and gullies were observed. • Rills and gullies were also observed during the previous inspection on March 12, 2012.

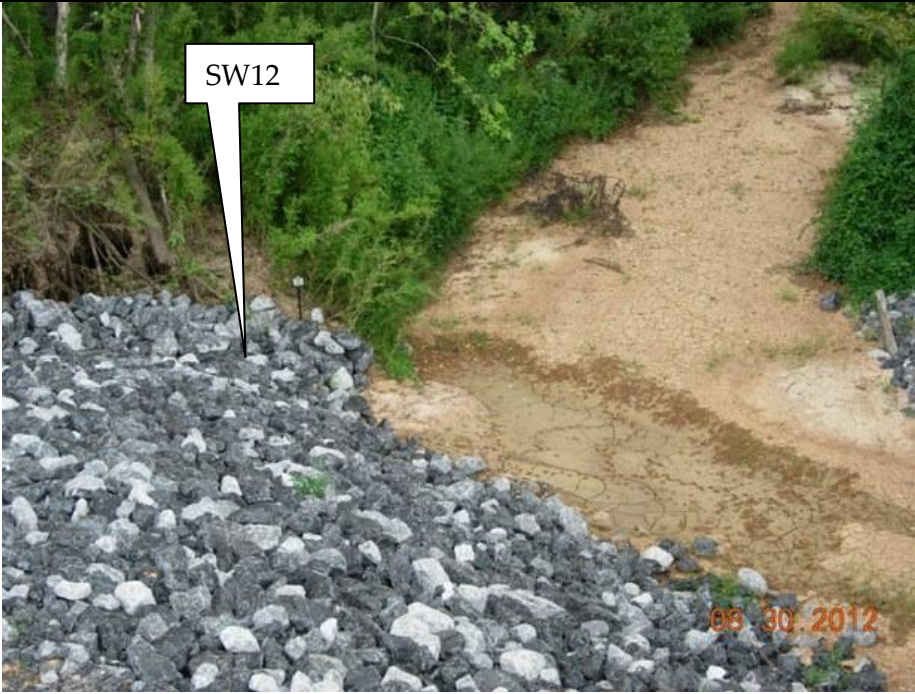
91	8-30-12		
Description <ul style="list-style-type: none"> • Phase 2 EC-27 • SW12 at Stream 6 • No discharge was occurring at the time of the inspection. • No flow was observed in Stream 6. However, accumulation of silt covering the stream bed appeared evident at and downstream of the discharge point of SW12. • The southern draining eastern drainage ditch, which conveys drainage to SW12, was not sufficiently stabilized/vegetated (see photos 92-96).

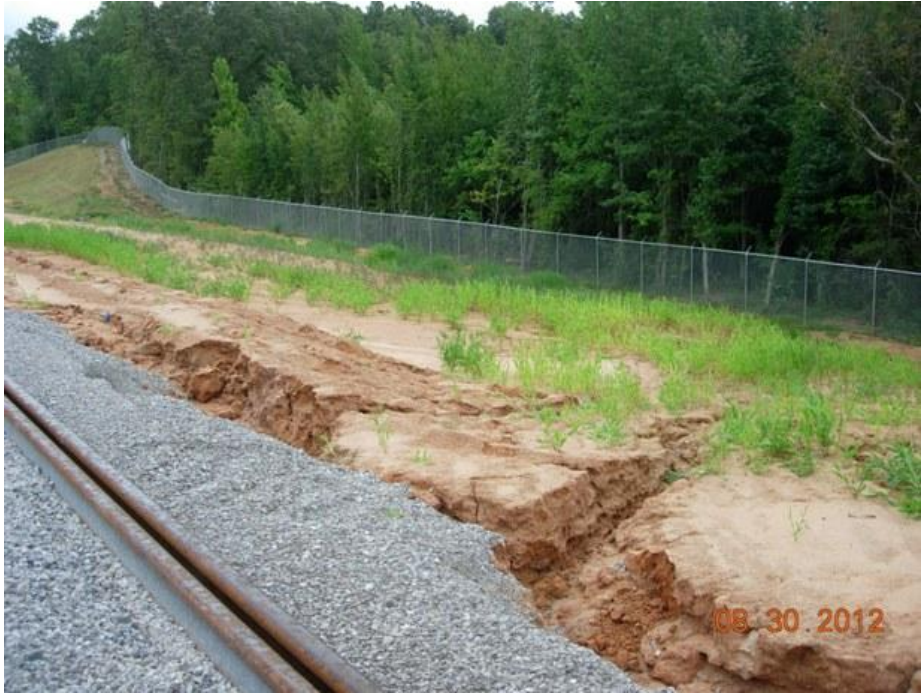
93	8-30-12		
Description <ul style="list-style-type: none"> • Phase 2 EC-27 • A portion of the top slope of the southern draining eastern drainage ditch, which conveys drainage to SW12, is shown in this photo. • The slope was not sufficiently stabilized/vegetated. • Gullies were observed.

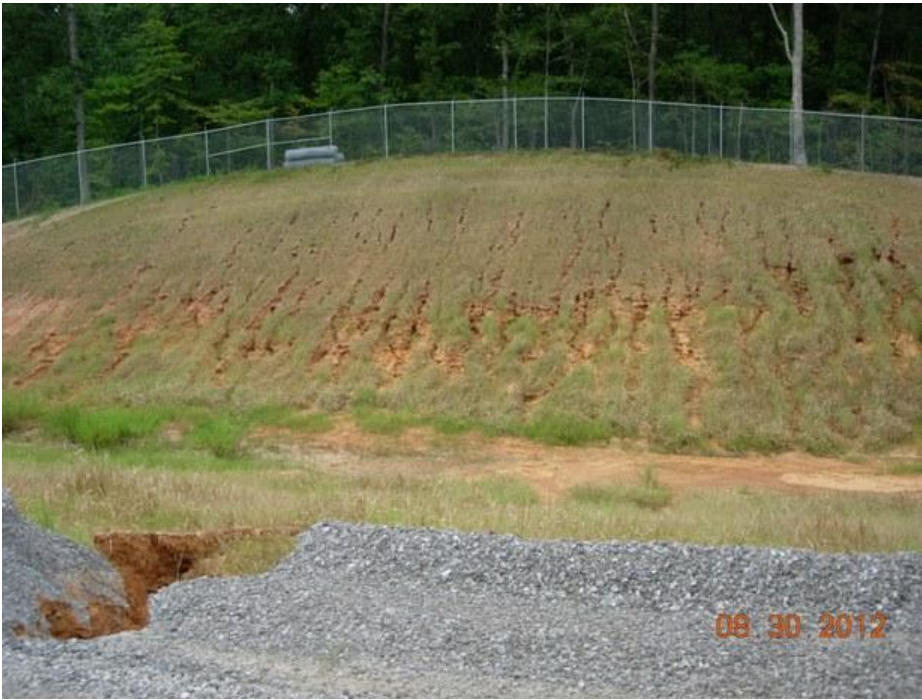
94	8-30-12		
Description <ul style="list-style-type: none"> • Phase 2 EC-27 • This photo shows an example of another portion of the southern draining eastern drainage ditch, which conveys drainage to SW12. • Vegetation/stabilization was not sufficient. • Rills and gullies were observed. • Sediment accumulation in the bottom of the swale is an indication of sediment loss from the slopes.

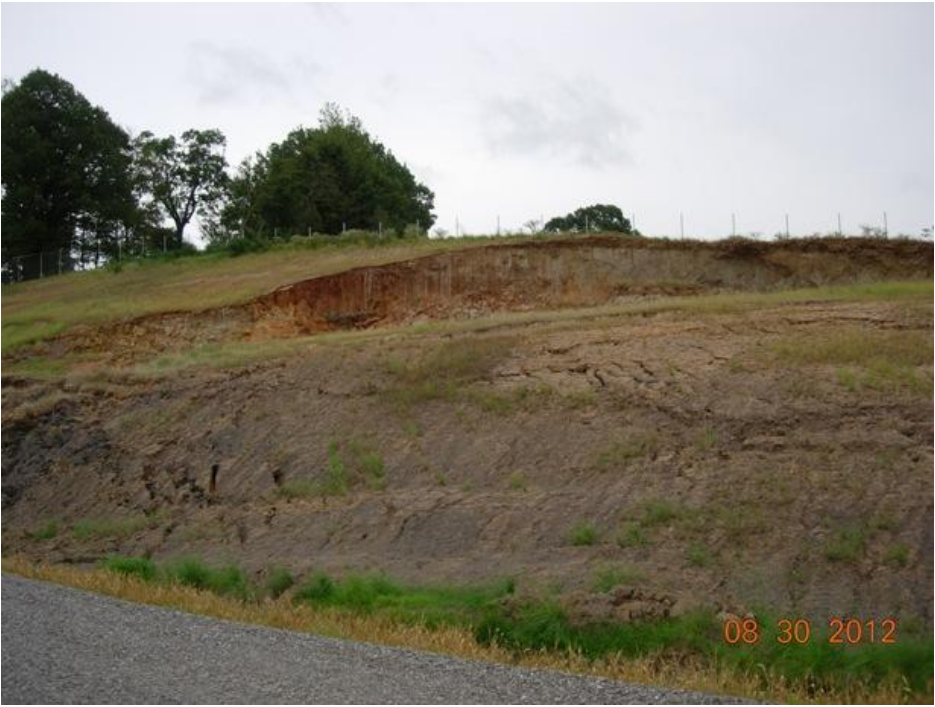
95	8-30-12		
Description <ul style="list-style-type: none"> • Phase 1A EC-17 • A massive slope failure has occurred on the northern end of the southern draining eastern drainage ditch (see also photo 96). • Vegetation/stabilization was not sufficient. • Rills and gullies were observed.

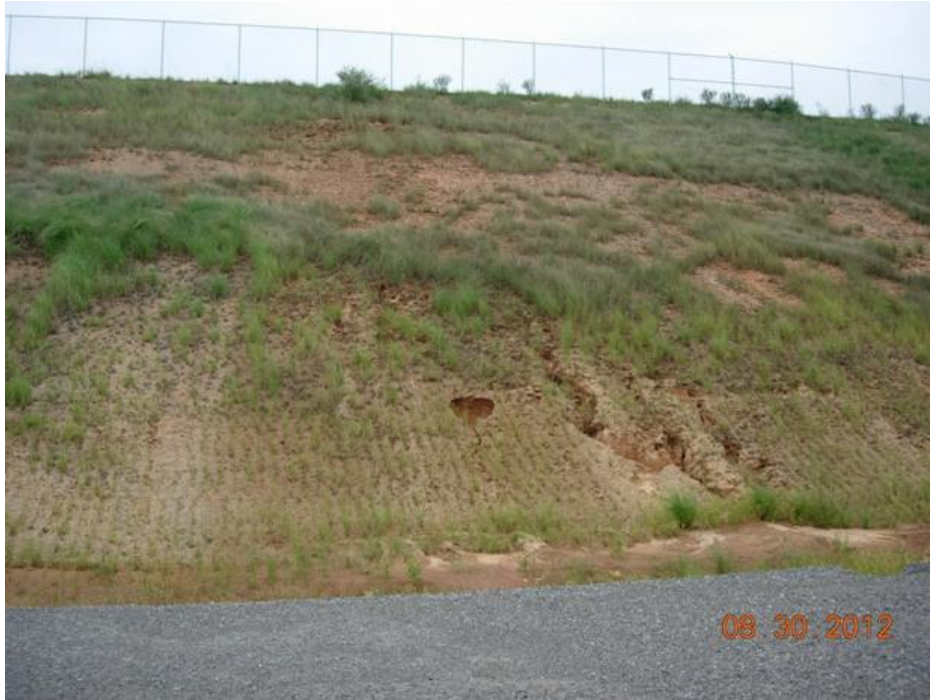
Photo No.	Date	 	
96	8-30-12		
Description <ul style="list-style-type: none"> • Phase 1A EC-17 • A massive slope failure has occurred on the northern end of the southern draining eastern drainage ditch. • Vegetation/stabilization was not sufficient. • Rills and gullies were observed.
